Limited Visual Dam Safety Inspection Summary Report

HI - 00027

E-13 Reservoir

May 2006

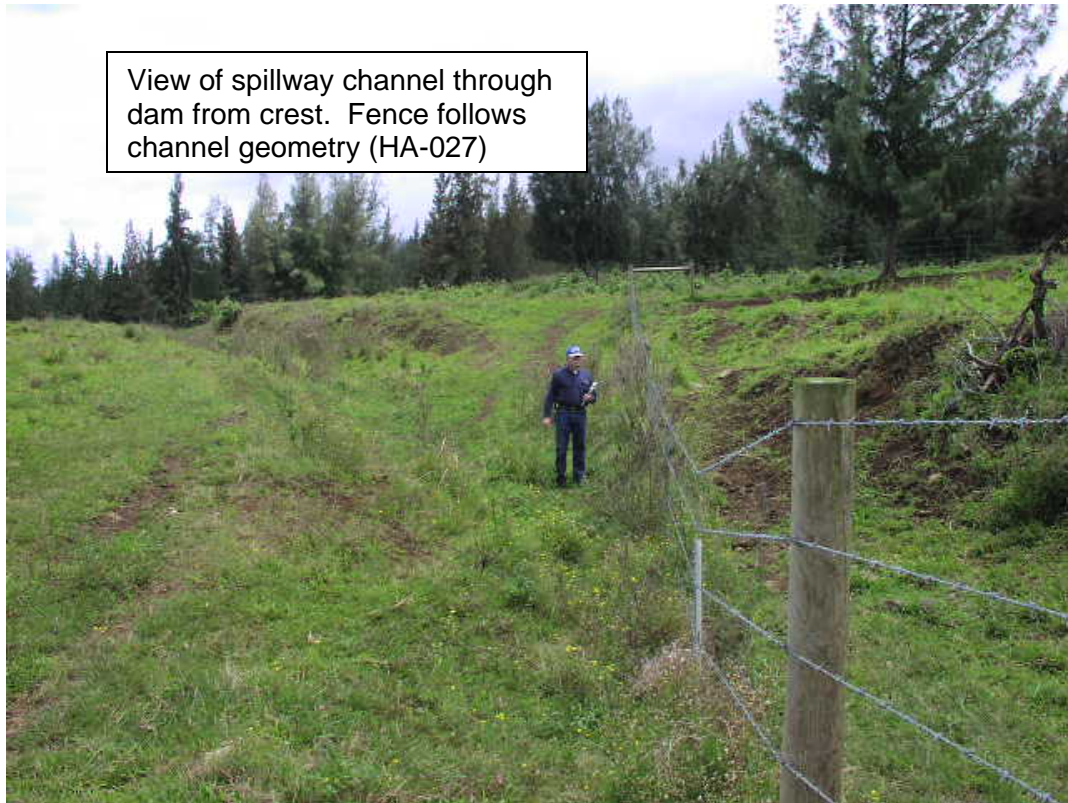
View of spillway channel through dam from crest. Fence follows channel geometry (HA-027)

- a. The Spillway appeared to be in unsatisfactory condition and would not expected to fulfill its intended function.
- b. If the reservoir is no longer needed, it is recommended to completely breach or remove the embankment to natural ground level.

The spillway appears to be cut down to keep the pool drained, thus breaching the structure. Recommend completing breach at existing spillway. No lining should be required; downstream channel is open, overland flow. No risk downstream to inhabited structures.

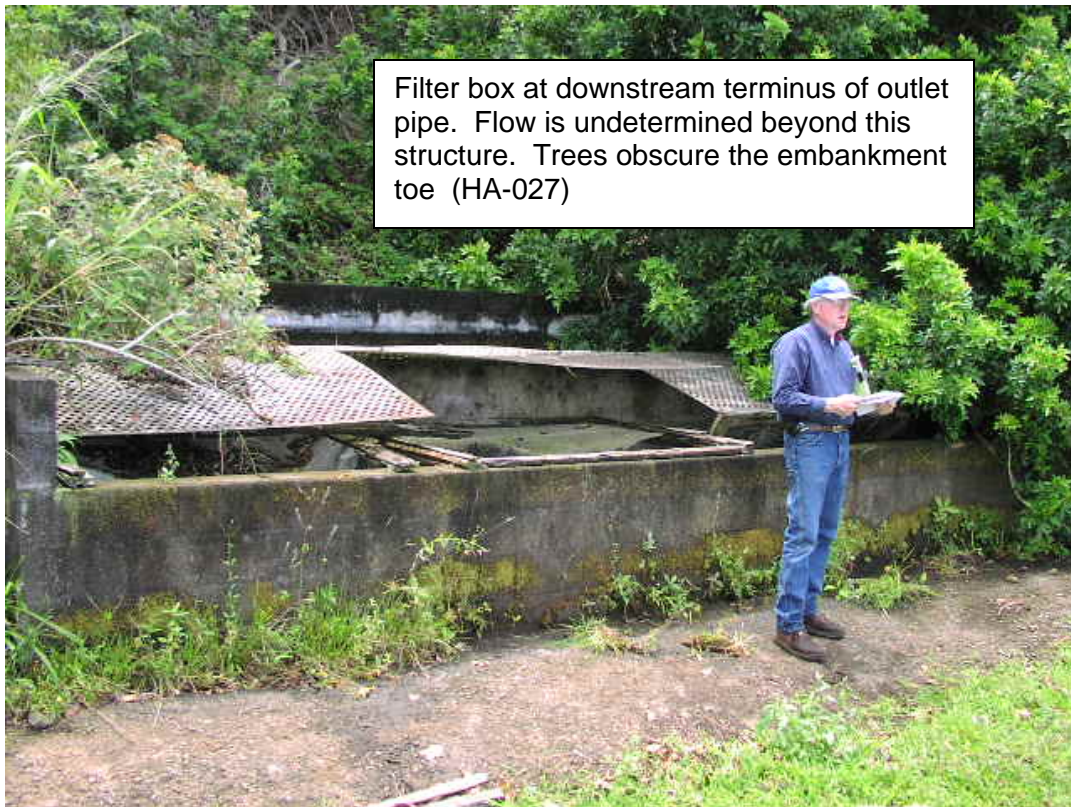
Filter box at downstream terminus of outlet pipe. Flow is undetermined beyond this structure. Trees obscure the embankment toe (HA-027)

- a. The outlet works were not tested.
- b. The original access bridge is an attractive nuisance and should be removed as soon as possible to avoid injury to curious visitors. Site access is not restricted.
- c. The outlet works appeared to be in unsatisfactory condition and not expected to fulfill its intended function. Corrective action is required if the dam is to be preserved.
- d. Filter boxes at the downstream end of the outlet pipe were not clearly visible due to high grass and bush vegetation. Clear high vegetation and maintain low to enable easy visual inspection.
- e. Tree(s) were observed on the dam embankment. Trees have been identified as the probably cause of piping failures, and can possibly cause severe damage to the embankment if they are uprooted during a high winds. Corrective action is required to remove the tree hazards from the dam. Acceptable remedies include
